# Manhole Inspection Summary

Manhole # S69M\_\_008MH

Insp Date: **2/5/08 11:51 AM**

**Location** Address: **6719 German Hill Rd.** Cross Street: **Bethlehem Ave.**

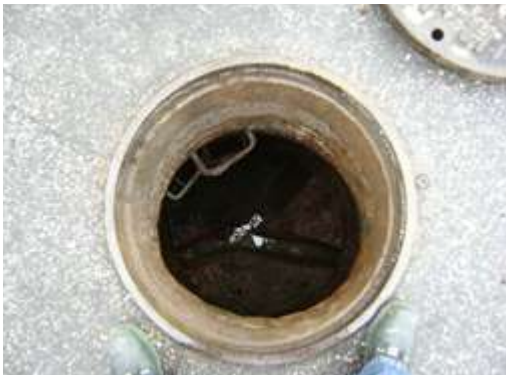
Defect 1

**Frame** Offset: **2** (in.) Condition: ☐ Sound ☒ **Cracked** ☒ **Leaks**

frame offset

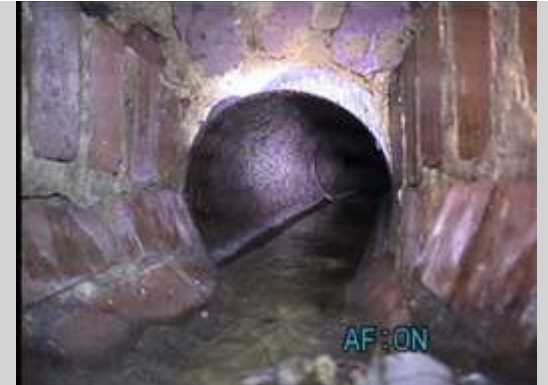
12 O'Clock Outflow

8 in. Circular Gravity Sewer  
Pipe Out @ 12 O'Clock

Pipe Height: **8.4** (in.) Rod and Bar (Angled)  
Pipe Material: **Clay** ☐ Pipe Lined  
Invert Depth: **9.33** (ft.) Flow Characteristics: **Slow**  
Deposits: ☐ None ☐ Mud ☒ **Sludge** ☐ Debris ☐ Grease  
Silt Depth: **0.25** (in.) Deposits Extent: **Light**  
Infiltration: **None** Pipe Seal Cond: **Sound**

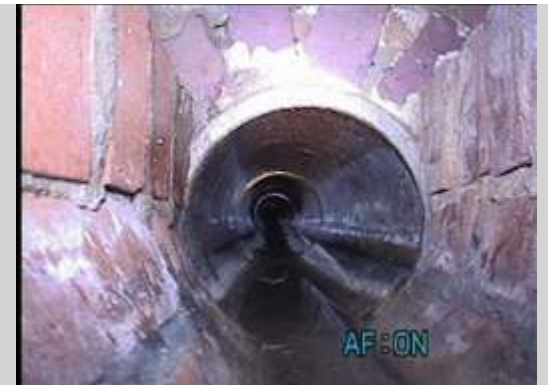
6 O'Clock Inflow

8 in. Circular Gravity Sewer  
Pipe In @ 6 O'Clock

Pipe Height: **8.4** (in.) Rod and Bar (Angled)  
Pipe Material: **Clay** ☐ Pipe Lined  
Invert Depth: **9.25** (ft.) Flow Characteristics: **Slow**  
Deposits: ☐ None ☐ Mud ☒ **Sludge** ☐ Debris ☐ Grease  
Silt Depth: **0.25** (in.) Deposits Extent: **Light**  
Infiltration: **None** Pipe Seal Cond: **Sound**

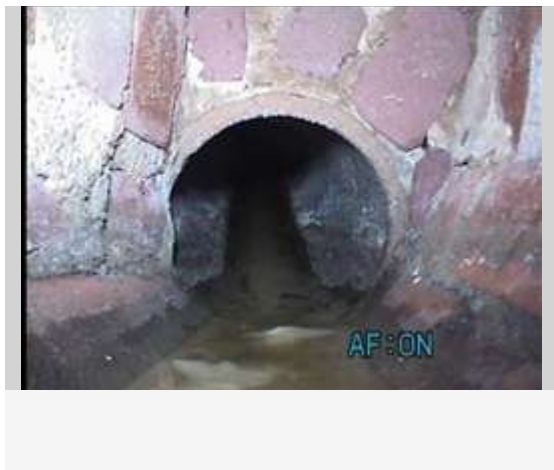
8 O'Clock Inflow

6 in. Circular Gravity Sewer  
Pipe In @ 8 O'Clock

Deposits: ☐ None ☐ Mud ☒ **Sludge** ☐ Debris ☐ Grease

Silt Depth: **0.25** (in.) Deposits Extent: **Light**
